DEPARTMENT OF TRANSPORTATION**DIVISION OF ENGINEERING SERVICES**

Contract #: 04-0120F4Cty: SF/ALA Rte: 80 PM: 13.2/13.9File #: 1.28**WELDING INSPECTION REPORT****Resident Engineer:** Siegenthaler, Peter**Address:** 333 Burma Road**City:** Oakland, CA 94607**Report No:** WIR-022725**Date Inspected:** 18-Apr-2011**Project Name:** SAS Superstructure**OSM Arrival Time:** 700**Prime Contractor:** American Bridge/Fluor Enterprises, a JV**OSM Departure Time:** 1530**Contractor:** American Bridge/Fluor Enterprises, a JV**Location:** Job Site

Caltrans Office of Structural Material (OSM) Quality Assurance Inspector (QAI) Joselito Lizardo was present at the Self Anchored Suspension (SAS) job site as requested to perform observations on the welding of components for the San Francisco Oakland Bay Bridge (SFOBB) Project.

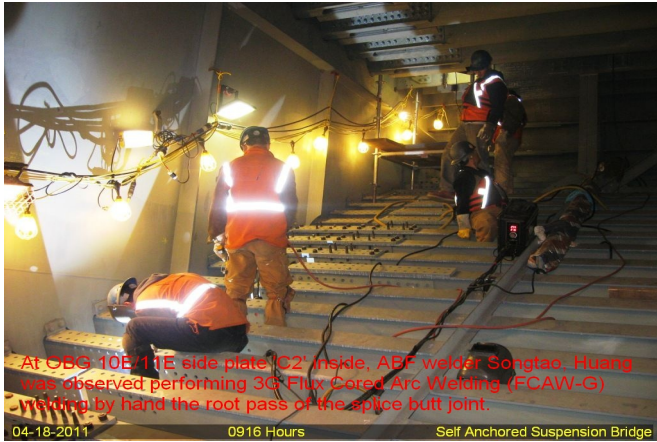
At OBG 10E/11E side plate 'C2' (0mm to 2638mm) inside, QA randomly observed ABF/JV qualified welder Sungtao, Huang ID # 3794 continuing to perform CJP groove (splice) welding root pass on the splice butt joint. The welder was observed perform automatic welding in the 3G (vertical) position utilizing a dual shield Flux Cored Arc Welding (FCAW-G) with E71T-1M, 1/16" diameter wire electrode and implementing Caltrans approved Welding Procedure Specification (WPS) ABF-WPS-D15-3042B-1. The joint being welded had a single V-groove butt joint with backing bar. The splice joint was preheated and maintained to greater than 150 degrees Fahrenheit using propane gas torch prior welding. During welding, ABF Quality Control (QC) William Sherwood was noted monitoring the welding parameters of the welder. During the, root pass welding on the splice butt joint location mentioned above was completed and the welder has spent the rest of the day diverting the water from getting into the weld due to the rain today.

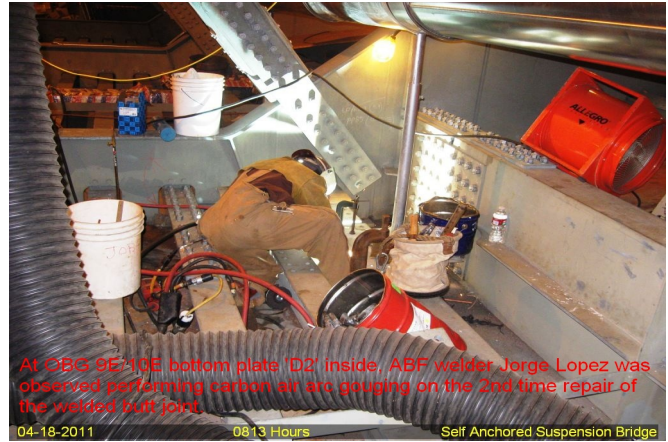
At OBG 9E/10E bottom plate 'D2' inside, QA randomly observed ABF/JV qualified welder Jorge Lopez perform CJP groove welding repair. The welder was observed welding in the 1G (flat) position utilizing Shielded Metal Arc Welding (SMAW) with 1/8" diameter E7018H4R electrode implementing welding procedure ABF-WPS-D15-1001-Repairs. The second time repair excavation located at Y=3600mm and was having excavation profile of 150mm long x 32mm wide x 20mm deep was preheated to more than 140 degree Fahrenheit using propane gas torch prior welding. During the shift, ABF QC William Sherwood was noted monitoring the
